Qualification of the microseismic monitoring technique applied to the risk of collapse in iron ore mines

G. Senfaute¹, M. Abdul Wahed², J.P. Piguet², J.P. Josien¹

¹Institut National de l'Environnement Industriel et des Risques (INERIS), 54042 Nancy, France

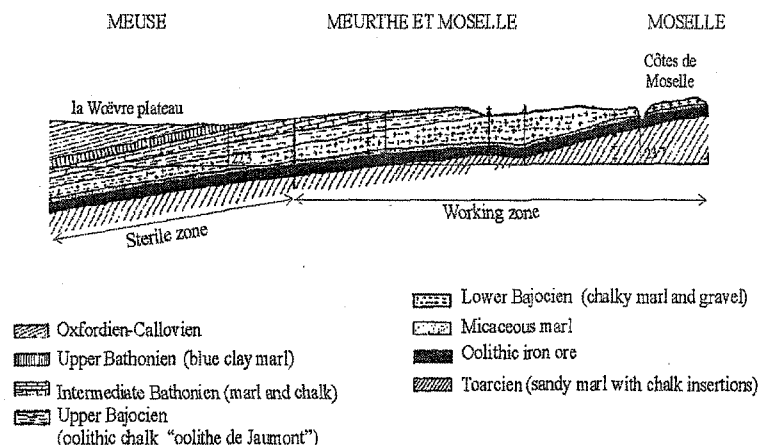
Figure 1: Simplified geological section of the Lorraine iron ore basin

The iron ore basin in Lorraine extends between the cities of Luxembourg in the north and Nancy (France) in the south. The iron ore deposit is sedimentary Aalenian and an insertion in the geological series between the Lias and the Jurassic (Tincelin, 1958). This deposit is virtually horizontal with a regular average slope of 3% and a mean thickness of 30 metres (figure 1). The sterile rocks lying above the iron-bearing formation known as "dead ground" have an average thickness of

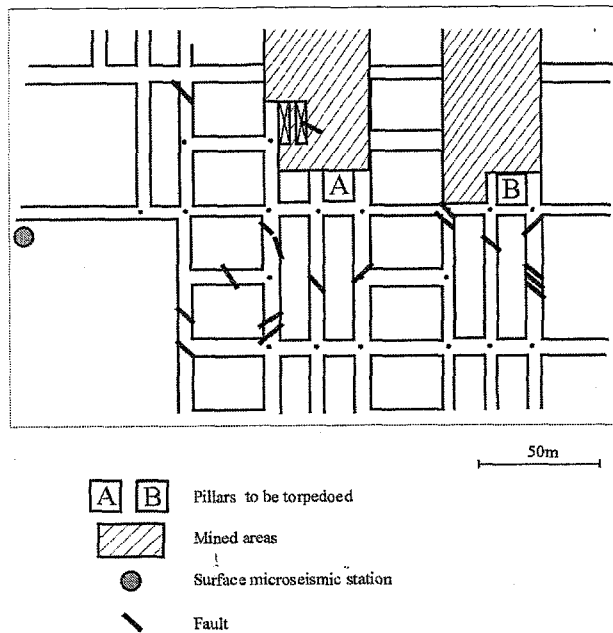
Figure 2: Plan view of the mine workings and location of the microseismic monitoring station at the surface

The geometry of the mining unit monitored by the microseismic technique is shown on figure 2. In this unit, the width of the islands is 40 metres, the strips between the islands are 30 metres wide and the mining height is 4 metres. The microseismic monitoring station was installed at the surface, in a borehole 30 metres in depth and about 300 metres from the mining operations. The microseismic station is a three-directional unit consisting of sensors of the accelerometer type with a pass band of 2 to 2300 Hz and a sensitivity of 500 mV/g. The signals are fed to a local computer with a sampling frequency of 10 kHz (figure 3).

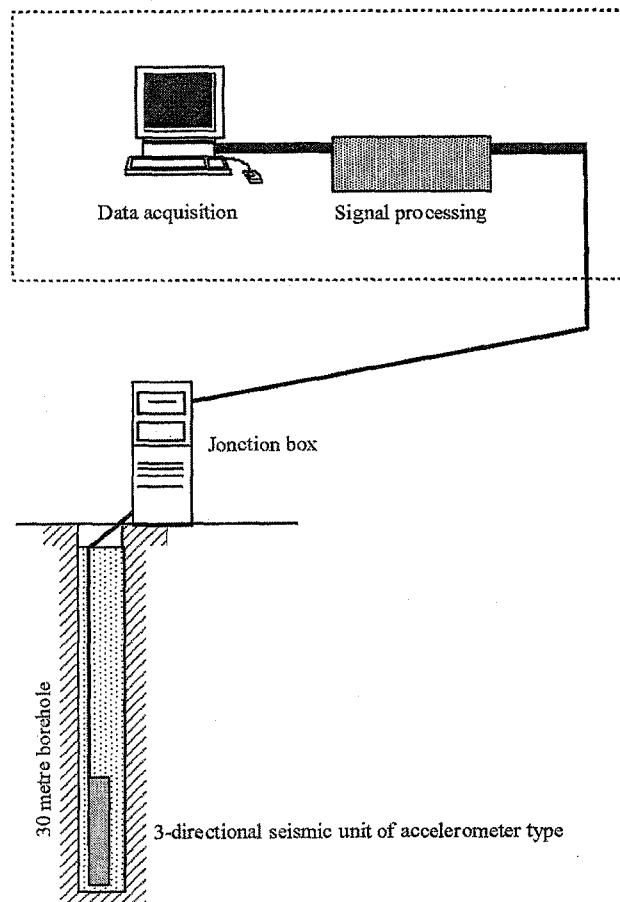
Figure 3: Microseismic measuring system

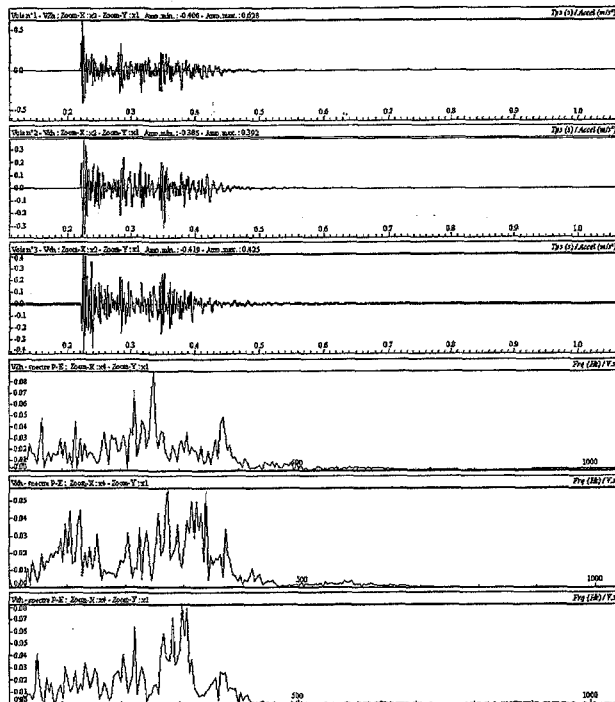
Figure 4: Examples of seismic signals and frequency spectra recorded during blasting operations some 300 metres from the seismic monitoring station on the surface.

All the blasting done during mining operations located 300 metres from the seismic station was systematically recorded by the seismic monitoring system. The signals recorded were of very high amplitude, leading to signal saturation. The signal frequency is about 200 Hz with peaks of up to 500 Hz.

Other blasts located about 600 metres from the monitoring station were also recorded. The maximum frequency of these events is lower (under 100 Hz) than the frequency of the events recorded during blasts located at 300 metres from the monitoring station. Finally, blasts some 900 metres from the monitoring station were not detected by the system. Figure 4 shows examples of seismic signals and of the frequency spectrum of the events recorded.

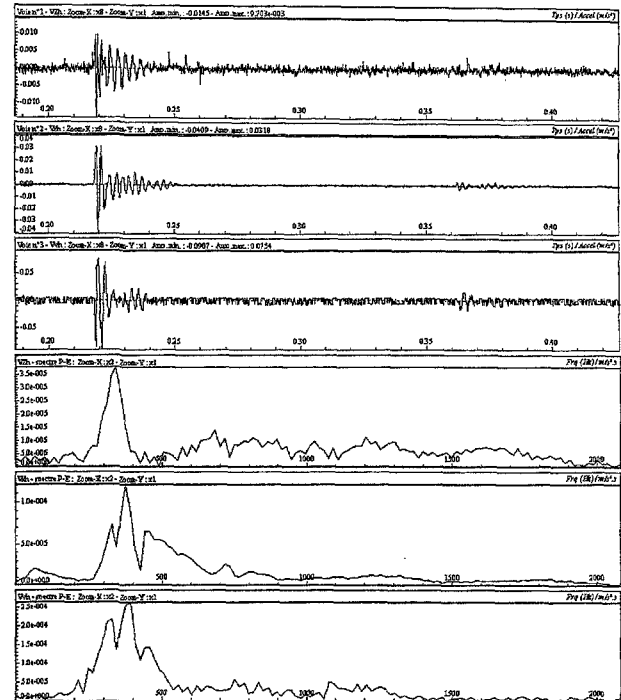
Figure 5: Examples of seismic signals recorded during the collapse of the roof. The difference with the signature of the seismic events associated with blasting can be clearly seen (see figure 4)

The collapse of the roof following the torpedoing of pillars A and B (see figure 3) generated 66 microseismic events. These events were characterised by their arrival in bursts, i.e., a number of events recorded in a short period of time. The signature of the signals and the spectral content of these events are appreciably different from those associated with blasting. They are very short events with maximum frequency peaks between 400 and 500 Hz (figure 5).
